NTSB Analyzes Crash in Virgin Islands

(Following is the first part of a report by the National Transportation Safety Board on the Sept. 2, 1978, crash of an Antilles Air Boats Grumman G21A while on a flight from St. Croix to St. Thomas, Virgin Islands. The crash killed the captain and three passengers. The report will be continued in a subsequent issue.)

Synopsis

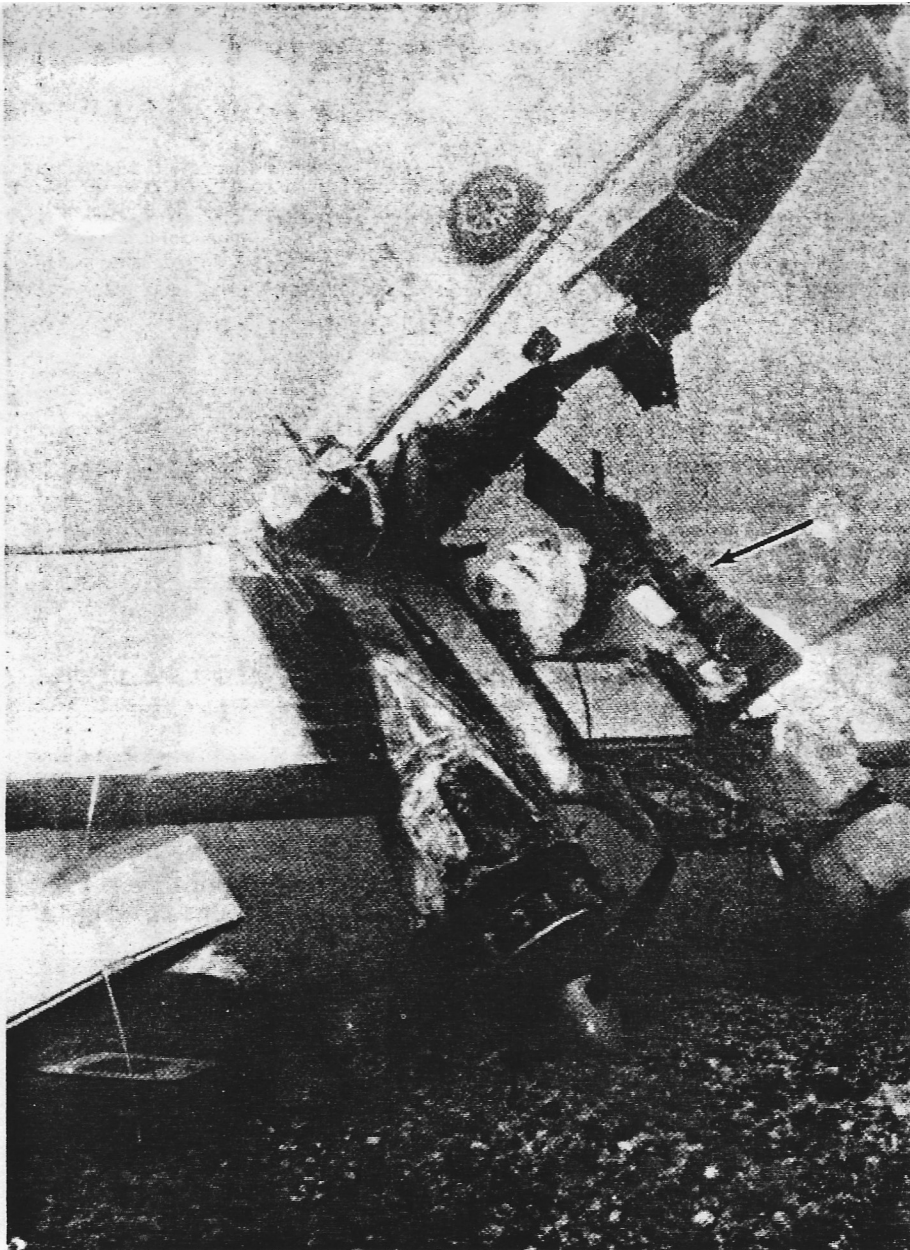
Wreckage of the Grumman G21A aircraft is shown 85 ft. below the surface of the ocean. Arrow indicates the right cabin wall structure still attached to the wing.

Wreckage and Impact Information. The aircraft landed in the open sea and broke up almost immediately. The fuselage, empennage and wings, with both engines attached, sank in 85 ft. of water. All pieces came to rest on the bottom of the ocean close together. Divers recovered all major sections of the aircraft with little additional structural damage.

The entire wing section, including both engines, remained attached to the fuselage. However, the wings separated from the attachment points at the leading edge and peeled rearward, remaining attached only where the trailing edge of the wing was joined to the fuselage. The right cabin wall structure remained attached to the wing. The wall separated from the fuselage along a vertical line from the wheel well to the right cockpit side window, and horizontally about 1 ft. below the cabin windows. The left cabin wall was torn diagonally from the top of the left side cockpit window, through the cabin windows, to the floorline at the base of the main entrance door.
