NATIONAL TRANSPORTATION SAFETY BOARD
Bureau of Technology
Washington, D. C.

Materials Laboratory
Report No. 87-15

METALLURGIST'S FACTUAL REPORT

Place : St. Croix, USVI
Date : October 28, 1986
Vehicle : Grumman Mallard G-73, N604SS
NTSB No. : MIA 87-F-A013
Investigator: Jeff Kennedy (MIA)

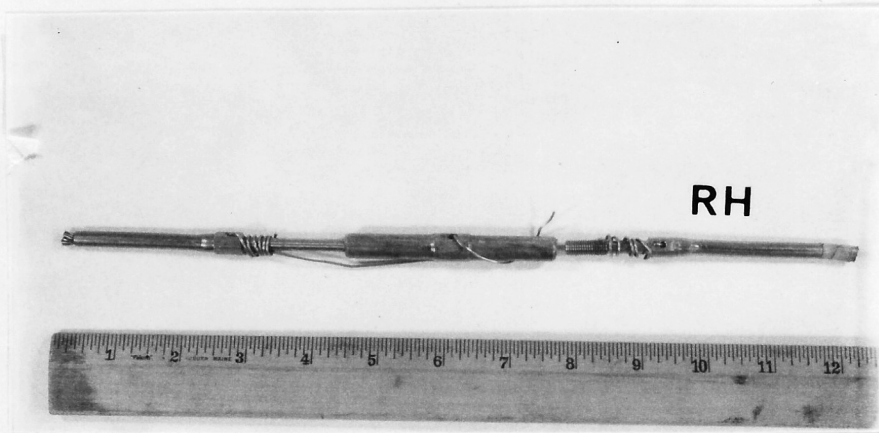
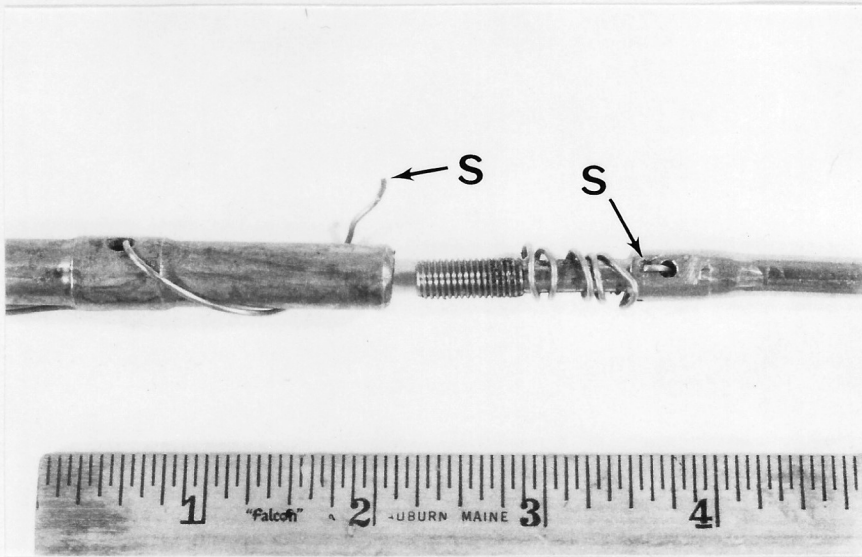
The received turnbuckle, labeled "aileron balance cable," was in two pieces, as shown in figure 1. One piece contained the turnbuckle barrel, the left hand threaded cable fitting and a length of fractured safety wire. The second piece was the right hand (RH) threaded cable fitting and the mating half of the fractured safety wire. The RH fitting appeared to have been unscrewed from the barrel and neither the barrel nor the RH fitting were fractured. In the laboratory it was demonstrated that the RH fitting could be screwed into the barrel with minimal effort up to the last four threads on the fitting which were slightly damaged. The mating threads on the barrel appeared to be undamaged.

The safety wire between the barrel and the RH fitting was fractured near the hole in the RH fitting. Close examination of the break with an optical microscope revealed features typical of an overstress break.

Figure 1. An overall view of aileron balance cable turnbuckle (upper view) with the disconnected RH fitting. Lower view shows the mating safety wire fractures at arrows "S".

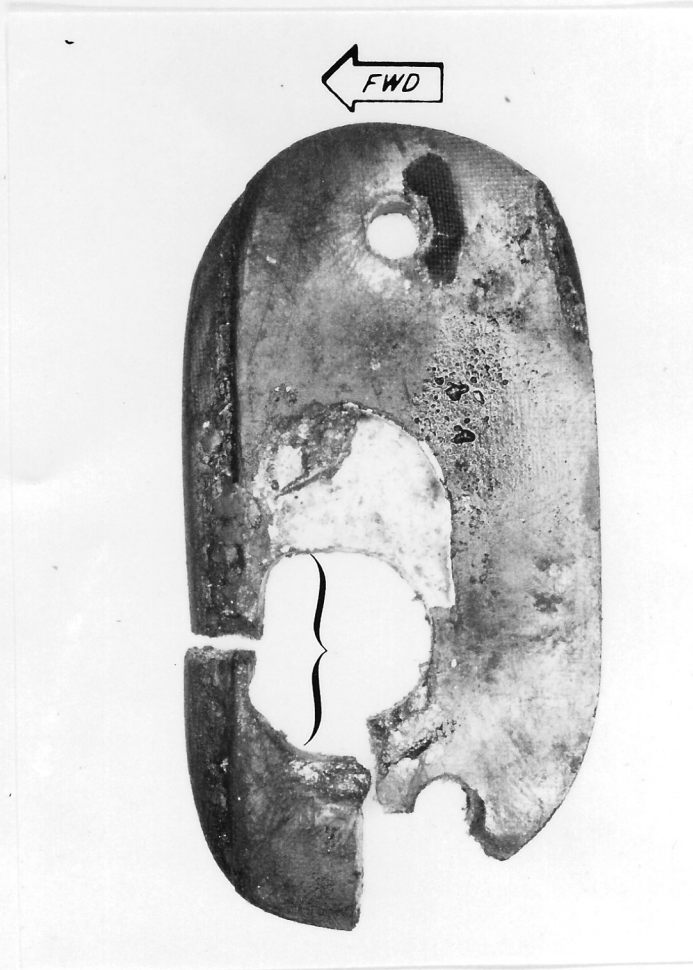
The left inboard aileron cable fairlead, shown in figure 2, was in three pieces, two of which were received. The fairlead was reported to have been found intact in the aircraft and was subsequently fractured during its removal. Inspections showed that the cable hole in the fairlead had been deformed such that the originally round hole resembled

the shape of a "D" with its straight portion vertical and toward the forward side of the hole. Microscopic inspection of the cable hole in the phenolic composite fairlead revealed scrape marks and evidence of mechanical removal of material from the forward side of the hole. Further, the contour of the enlarged hole suggests that the material was removed by sliding contact with the aileron cable.

Figure 2. View of the outboard surface of the left inboard aileron cable fairlead, fractured during removal. Black bracket indicates deformation of hole by aileron cable. Mag 4X.

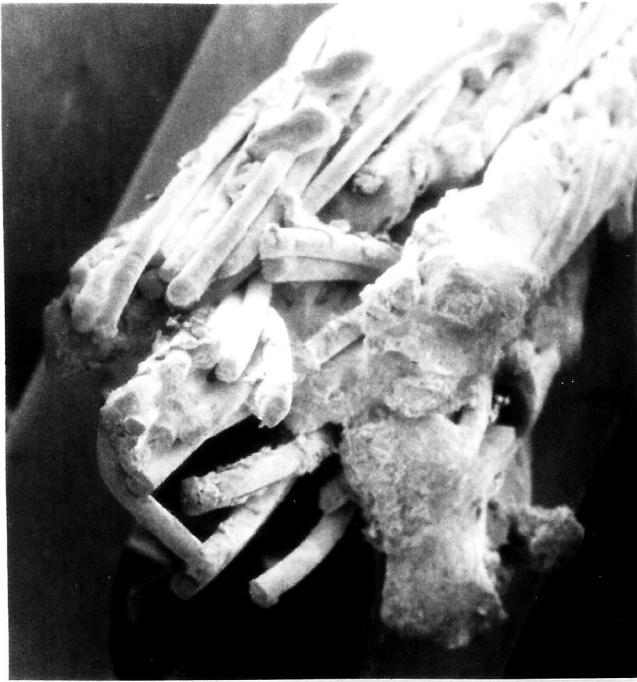
The wires at the separated ends of the left wing aileron cable had been melted and partially fused together. Almost all the wires on the inboard segment end were fused into one ball. Several fused balls were present on the separated end of the outboard cable segment. The fused end of the outboard segment is depicted in figure 3. In addition, wires were found fused together at many localized areas on the outer surface of the outboard cable segment as shown in figure 4. Energy dispersive x-ray analysis of the fused areas and the base wire of the cable established that both were representative of a 300 series stainless steel. However, significant additional amounts of aluminum were detected in the fused zones. These fusion areas were present along approximately 6.0 inches of the cable outboard from the separated end and tended to be on one half of the cable circumference. Heavy wear and some broken and protruding wire filaments were found in this area of the cable. The fusion at the end of the cable segments and along the surface of the outboard segment are indicative of intense localized heating consistent with electrical arcing.

Figure 3. An SEM macrograph (10X) of the fused end of the left aileron cable outboard segment.

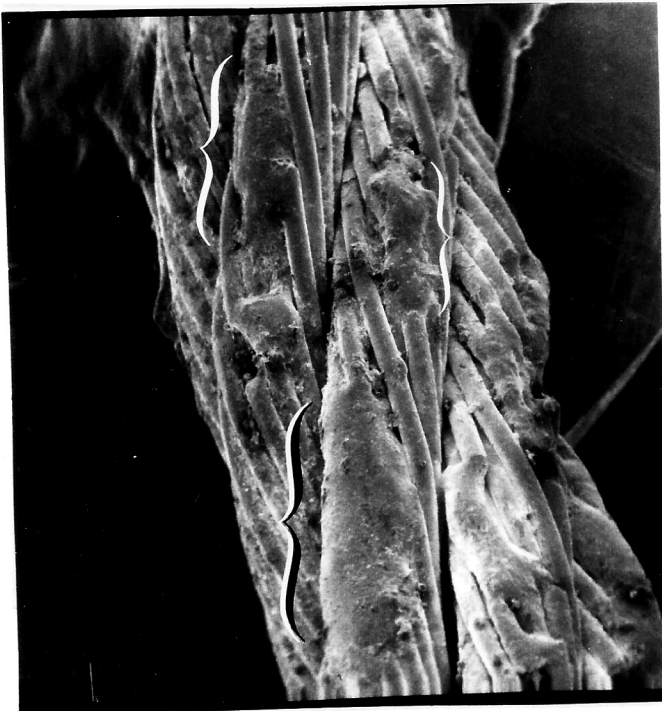
Figure 4. An SEM macrograph (10X) of fused wires (brackets) on the surface of the left aileron cable.

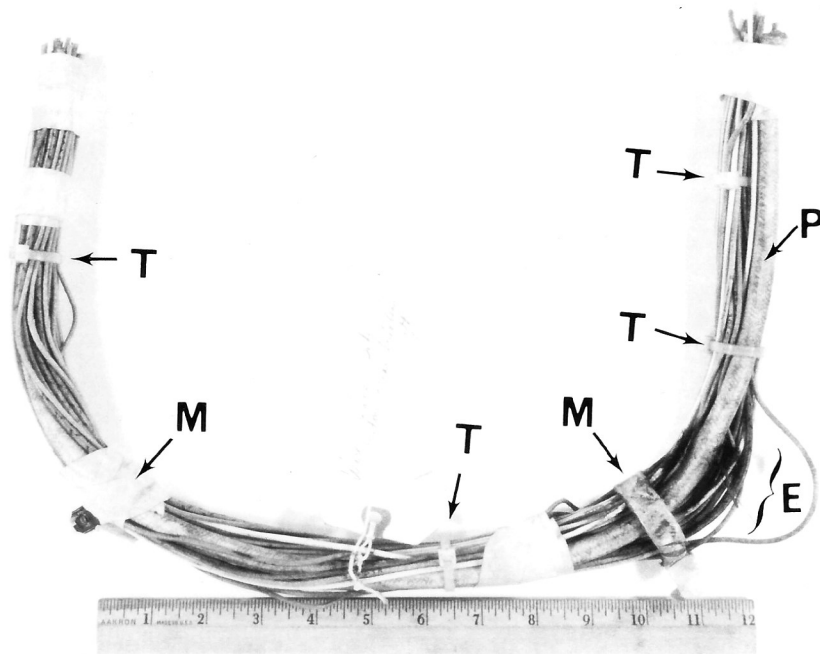
The received section of electrical wiring bundle is shown in figure 5. The bundle was made up of one large, approximately 7/16 inch diameter,

insulated power cable, arrow "P" in figure 3, and 35 smaller (14, 16, 18 and 20 gage) insulated electrical wires held together by 4 plastic wire ties, and two mechanical clamps, arrows "T" and "M" respectively in figure 5. The power cable reportedly connected the battery and the "J" box. The smaller wires were unidentified.

At the location of bracket "E" in figure 5, a 0.5 by 0.5 inch area of the power cable conductor was exposed and a 1.5 inch strand comprised of 13 wire filaments was protruding from the bundle. The exposed conductor and protruding wires were located on the side of the power cable facing the smaller electrical wires in the bundle. One of the mechanical clamps and one wire tie were removed from this area of the bundle to allow closer inspection the power cable.

Figure 5. An overall view of the electrical wiring bundle, with wire ties at arrows "T", clamps at arrows "M" and power cable at arrow "P". Bracket "E" denotes area of exposed power cable conductor and protruding wires.

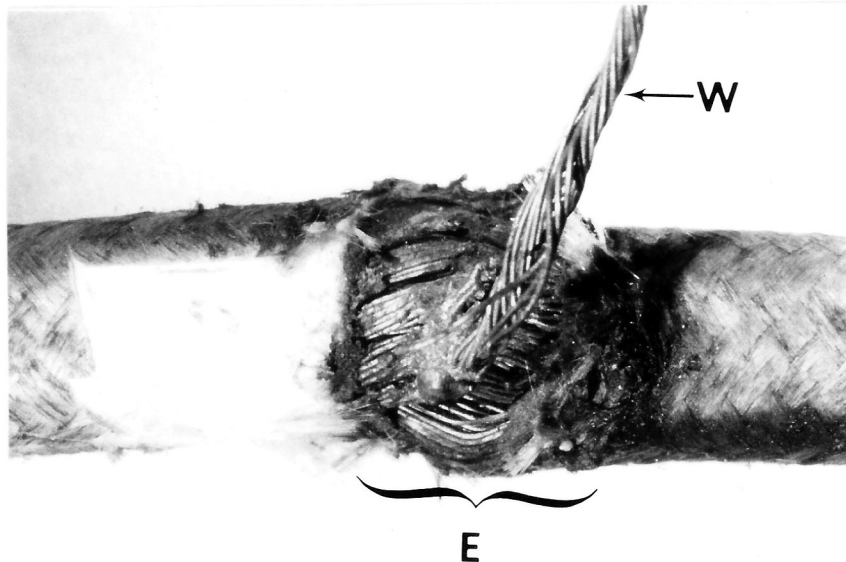
This inspection showed that the protruding wires were fused to the exposed power cable conductor and that these wires did not appear to have been part of the original conductor (see fig. 6). The protruding wires were approximately 0.01 inches in diameter and were later determined to be a stainless steel alloy in contrast to the aluminum coated copper power cable conductor wires. The plastic insulation and woven fiberglass abrasion shield were blackened and burnt along the edges of the exposed conductor area. In addition, scrape marks were found on many of the individual conductor wires. These scrape marks resemble marks left when a wire rope, such as a typical aircraft control cable, is slid across a surface. Eleven of the smaller electrical wires and one of the mechanical clamps showed evidence of localized heating in the immediate area of the exposed power conductor and protruding wire strand. However, the insulation was breached on only one of these wires.

Figure 6. A 3X view of the exposed area, bracket "E" on the power cable and the fused-on protruding wires, arrows "W". Fiberglass sheath to left was cut away during examination.
