ARCHEOLOGICAL INVESTIGATIONS AT  
**THUNDERBIRD LODGE**  
CANYON DE CHELLY, ARIZONA

SOUTHWEST CULTURAL RESOURCES CENTER PROFESSIONAL PAPERS  
NUMBER 20

**Archeological Investigations**  
**at**  
**Thunderbird Lodge**

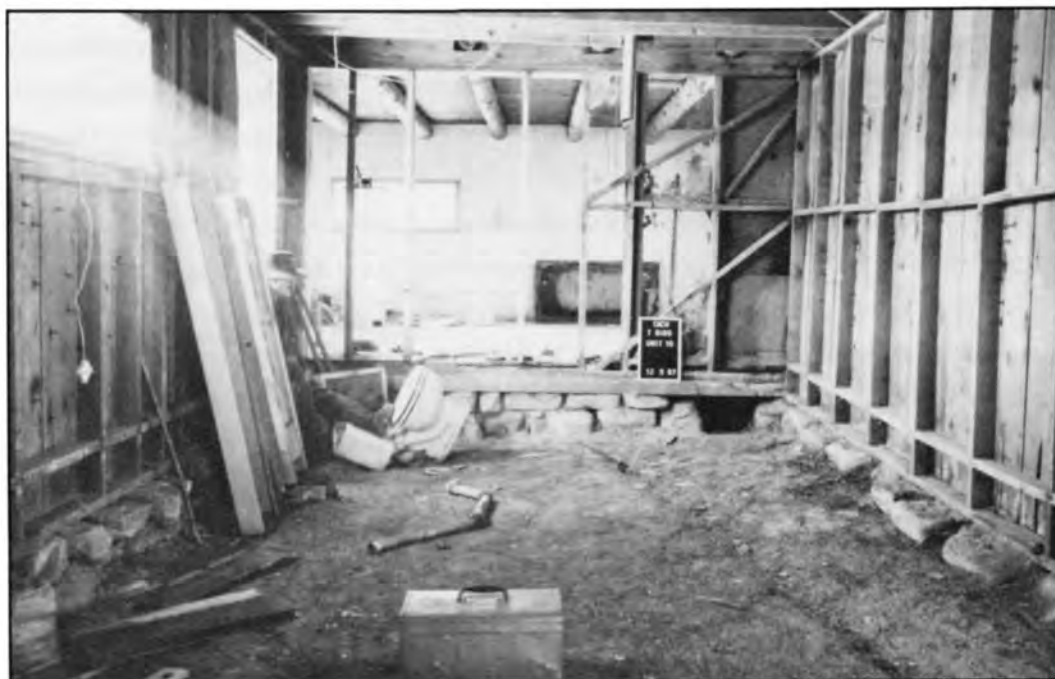
**Figure 1.5** Interior of Guest Unit 10 showing razed interior prior to renovation. Looking south into Guest Unit 11.

Work was undertaken in Guest Unit 10 of Building 13 in order to examine exposed subgrade surfaces and/or features. Building 13 is located directly west of the ranch house/gift shop across a small parking lot (Figure 1.4). Renovation of this room entailed complete interior remodeling, including installation of new walls, new ceiling, and replacement of the old wood and joist floor with a concrete slab. All interior furnishings, closure material, and subfloor deposits had been removed when archeological work began (Figure 1.5). The main concern in Building 13 was to test for evidence of an earlier structure or deposits under Unit 10.

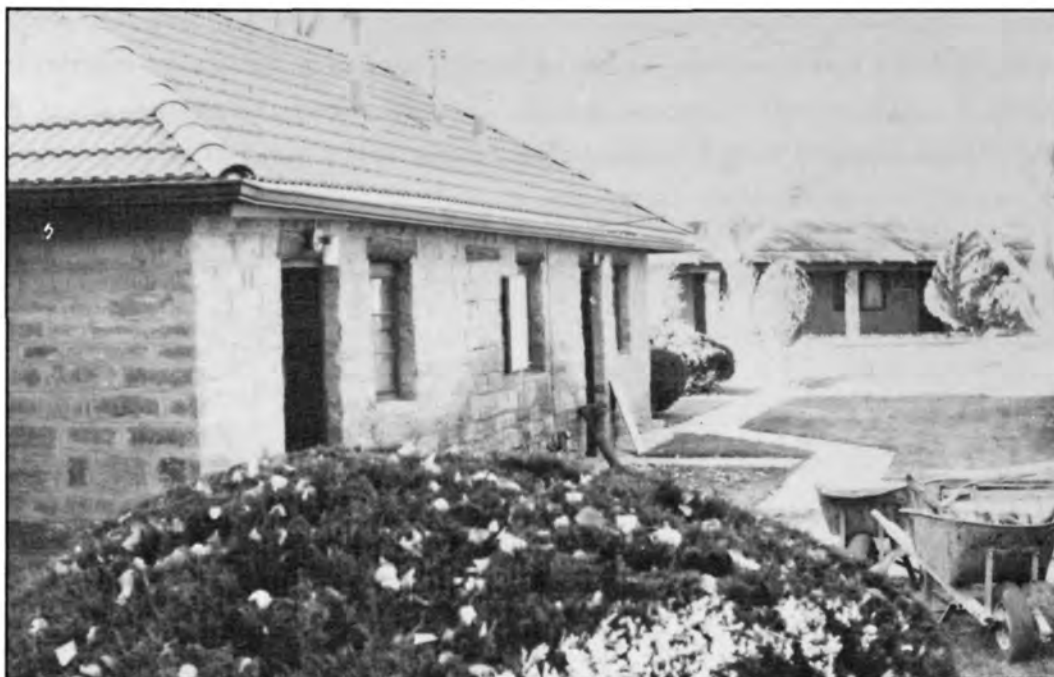
**Figure 1.9** Building 15 during remodeling. Looking north toward motel unit built in 1965.

Built as the first of the three stone visitor's cottages in 1920, Building 15 (Guest Units 6 and 8) is a rectangular structure 41 by 18 feet. Although smaller than its counterparts, Building 15 exhibited such similar characteristics as rusticated sandstone masonry set in cement mortar, tabular slab foundations of metamorphic rock, a hipped roof with asphalt roll roofing, earthen ceiling insulation, simple fenestrations, and rudimentary interior design (Figure 1.9).

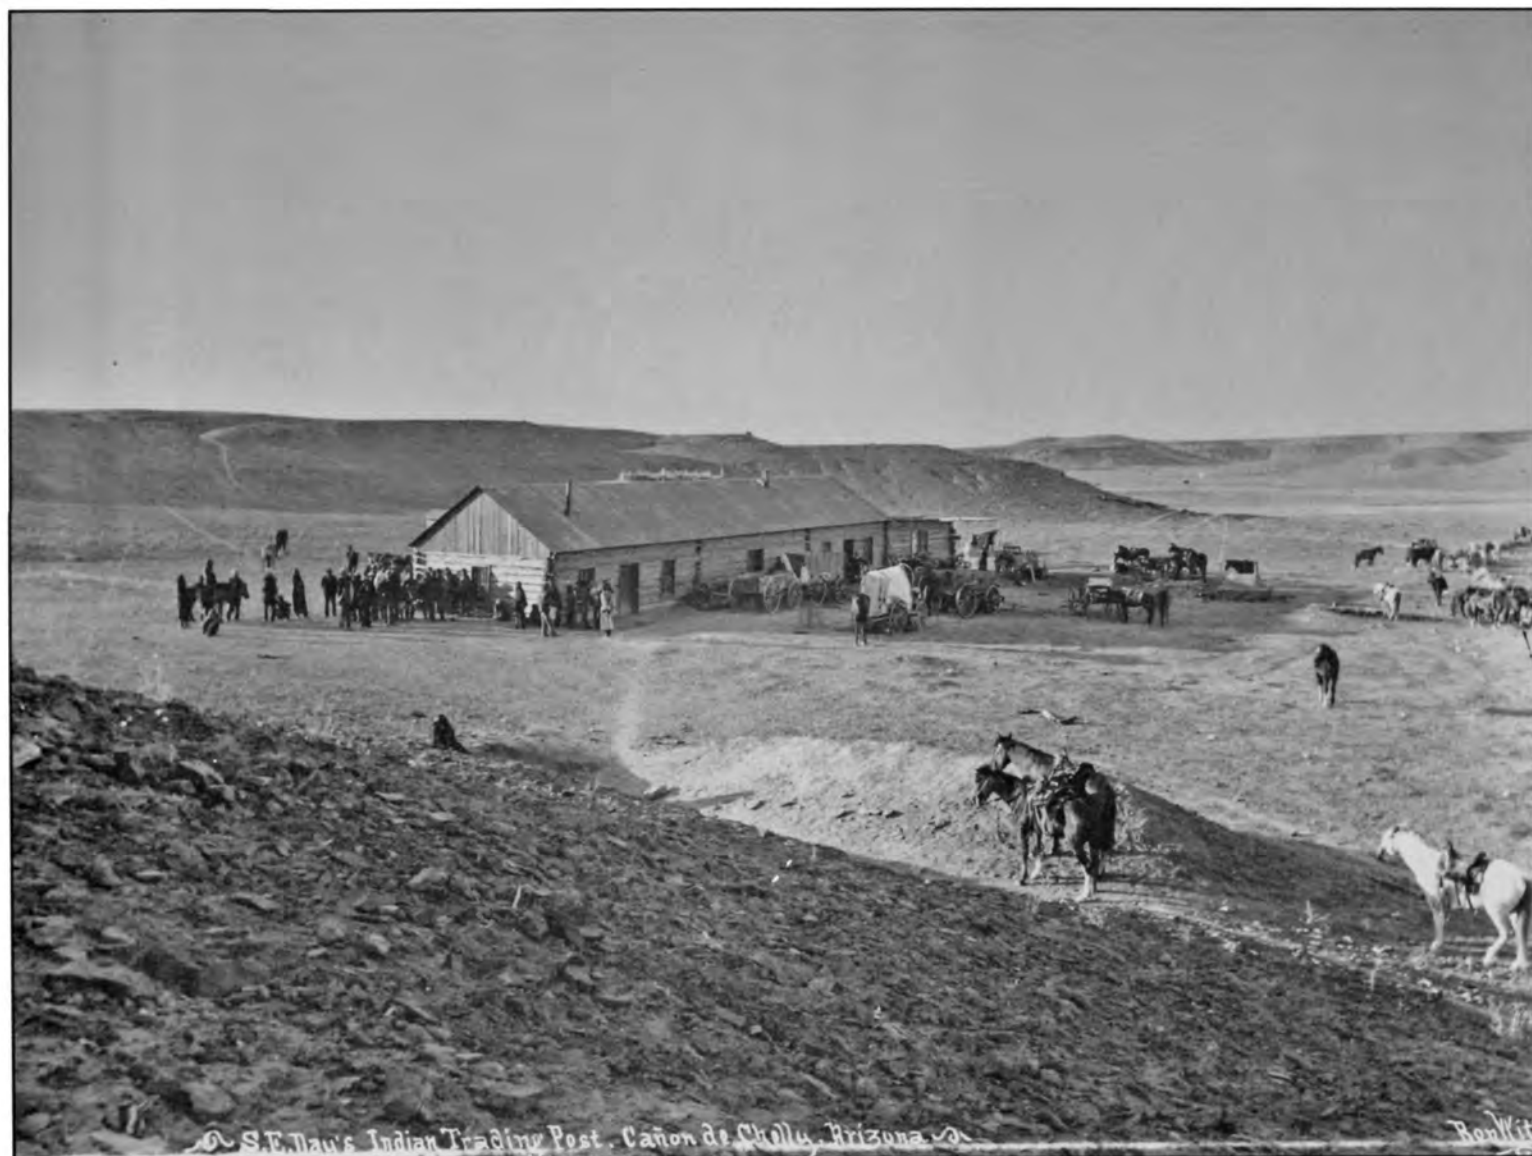
**Figure 2.3.** Sam Day's trading post (1902-03) with the excavation for the adobe structure in foreground. Day's flat-roofed living quarters are on the north end of the post with various activity areas and customers in front of the post. Photo by Ben Wittick, Courtesy School of American Research Collections in the Museum of New Mexico: Neg. No. 15988.

The two Wittick photos presented here (Figures 2.2 and 2.3) are the most widely published early photos of Day's trading post (for a listing see McKenna and Travis, this volume, Note 1). They both look northwest of Day's post, with Figure 2.3 taken at a slightly higher elevation, revealing outbuildings to the west of the post. These photos, and a third showing a southwest view of the post (Trafzer 1977:9), were all shot at the same time, judging from the consistent position of a wheelbarrow just north of the bread oven near where the Day family laundry is hanging on the north side of the post.

The Wittick photos show the entire development of Day's post. The post's central structure is the 60-by-20-foot trading post with a corrugated metal-covered and gabled roof. Attached to the north end of the post was the flat viga-and-dirt-roofed living quarters of the Days. A privy was situated about 100 feet west of the trading post and a structure for grain and fodder to the northwest. Some 150 feet east of the post was an alignment of large rocks that apparently formed one of the post's boundaries. Navajo horses can be seen tethered to the rocks in this alignment in Figure 2.3. Midway between the rocks and the post were a bread oven and work area. In the foreground of Figure 2.3 is the beginning of a dugout with leveling fill from the excavation piled to the north; two horses stand on the excavation's eastern margin. This excavation marks the beginning of work on Day's adobe outbuilding.

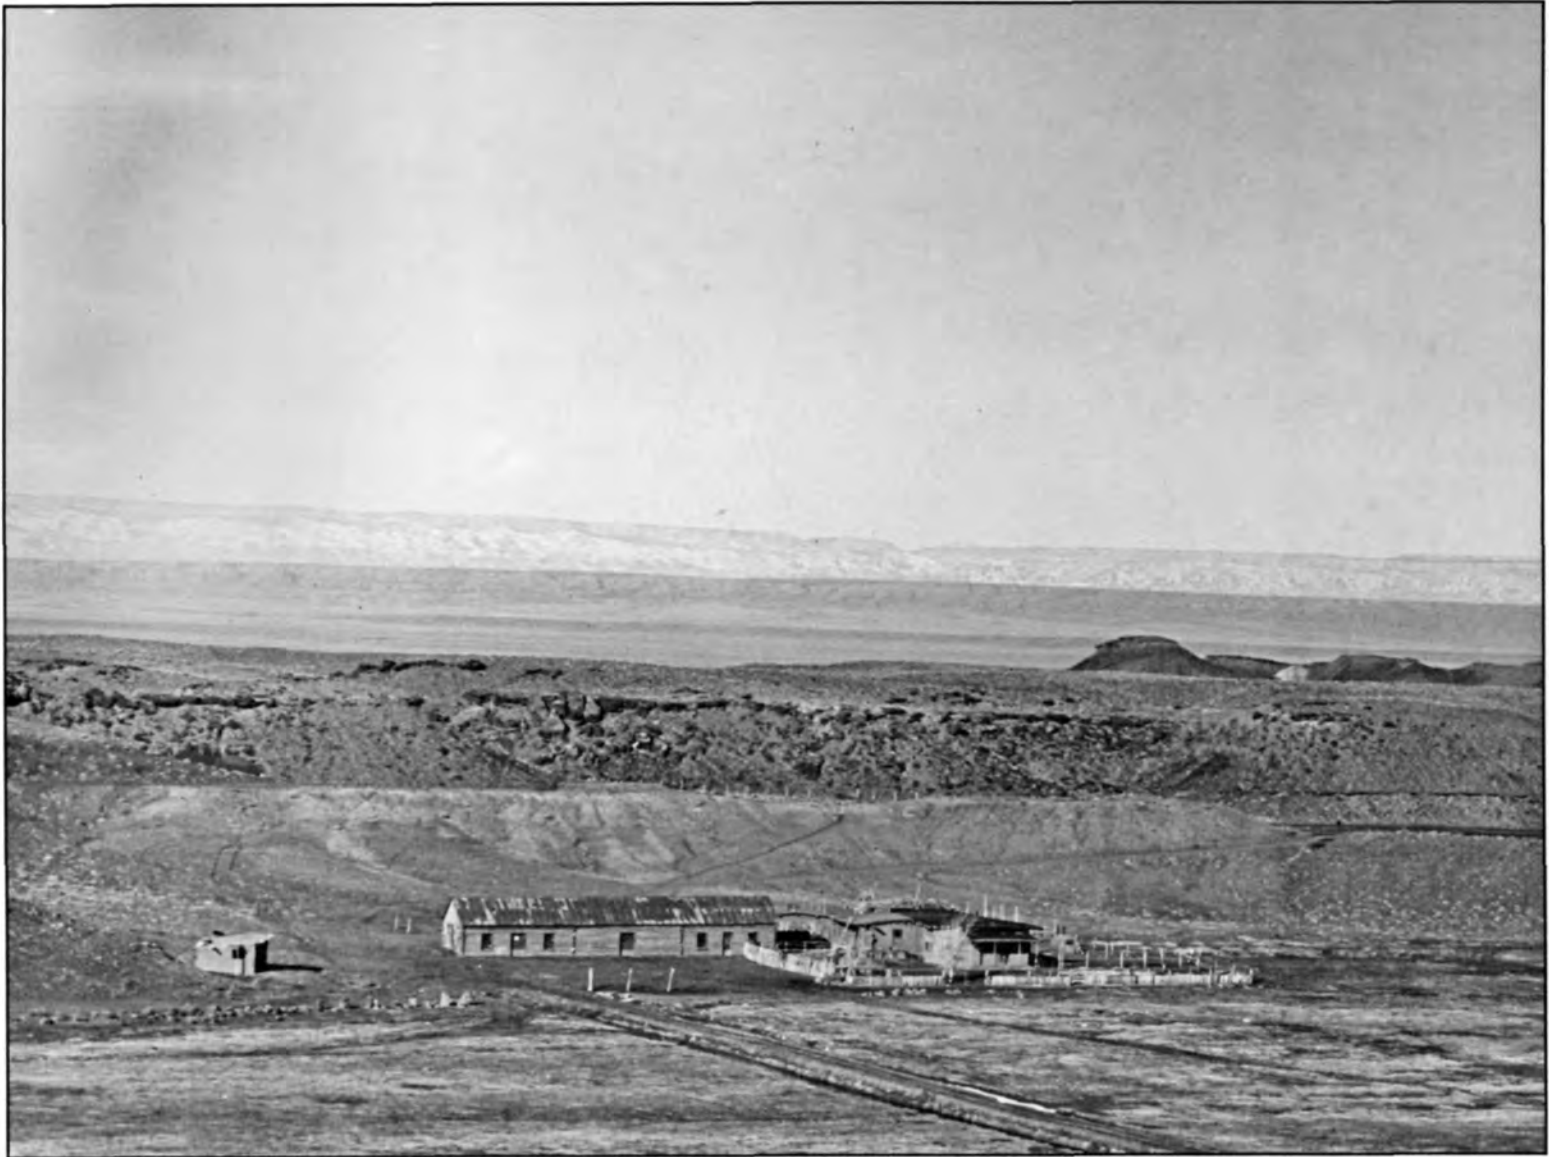
**Figure 2.4.** Overview to the west of Cousin's Chinle trading post operation showing the adobe structure to the south of the main complex. Photo courtesy of the Museum of Northern Arizona.

No photographs show the front (north) elevation of the outbuilding. The Bureau of Indian Affairs (BIA) photograph and the 1925 picture shown by Morris (1933) indicate the building had two chimneys in the two southern corners, suggesting two rooms. A small, high window can be seen toward the north end of the east wall (Figure 2.4). Also evident in Figure 2.4 is that the roof was sloped to the south with drainage to the back of the building. Other appointments to the building are speculative but the chimneys suggest two rooms may have been present and that each may have had its own entrance and window on the north elevation.

Both floors were smooth and devoid of features other than the fireplace (Figure 2.18). No evidence of any room fenestration or other wall features was noted in the remaining walls, although one window is visible in historic photographs of the east elevation (Figure 2.4).

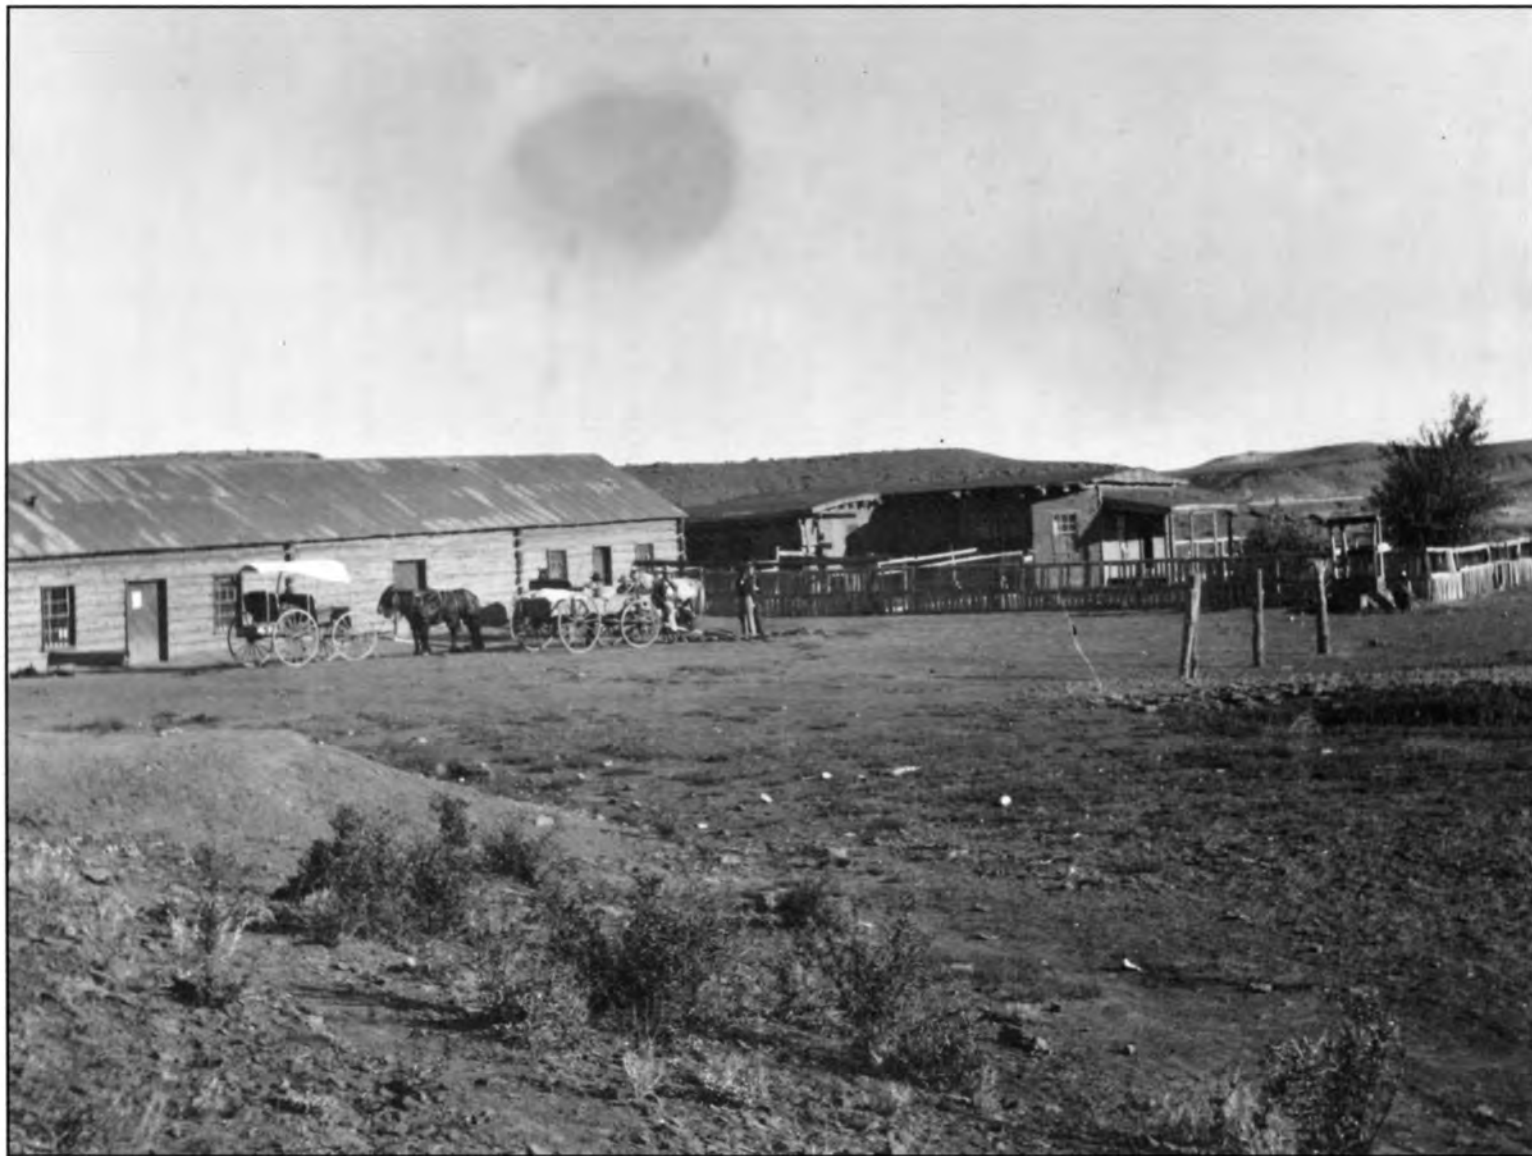
**Figure 2.5.** Weidemeyer's trading post under Cousin's management (circa 1906) showing the leveling pediment in front of the adobe structure and the eastern elevation of the post complex.

Although no actual documentation has been found on the specific use of the adobe building, some inferences can be made on the basis of photographs, architecture, and floor-associated materials. There was a well-worn foot path between the trading post and the structure (Figure 2.6), indicating frequent and direct interaction between the two buildings. Hitching posts were situated nearby (Figure 2.5).

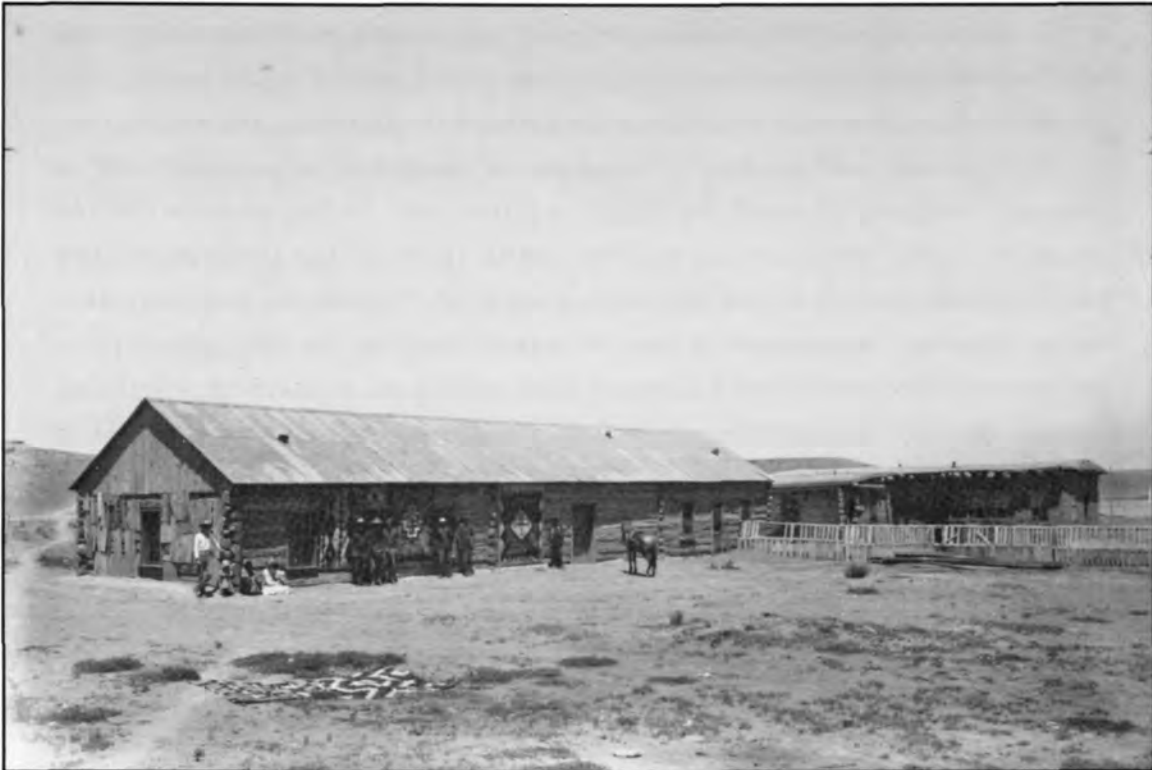
**Figure 2.6.** View to the northwest of Cousin's trading post showing footpaths to the adobe structure (southeast) and outbuildings west of the post. Photo courtesy of the Museum of Northern Arizona.

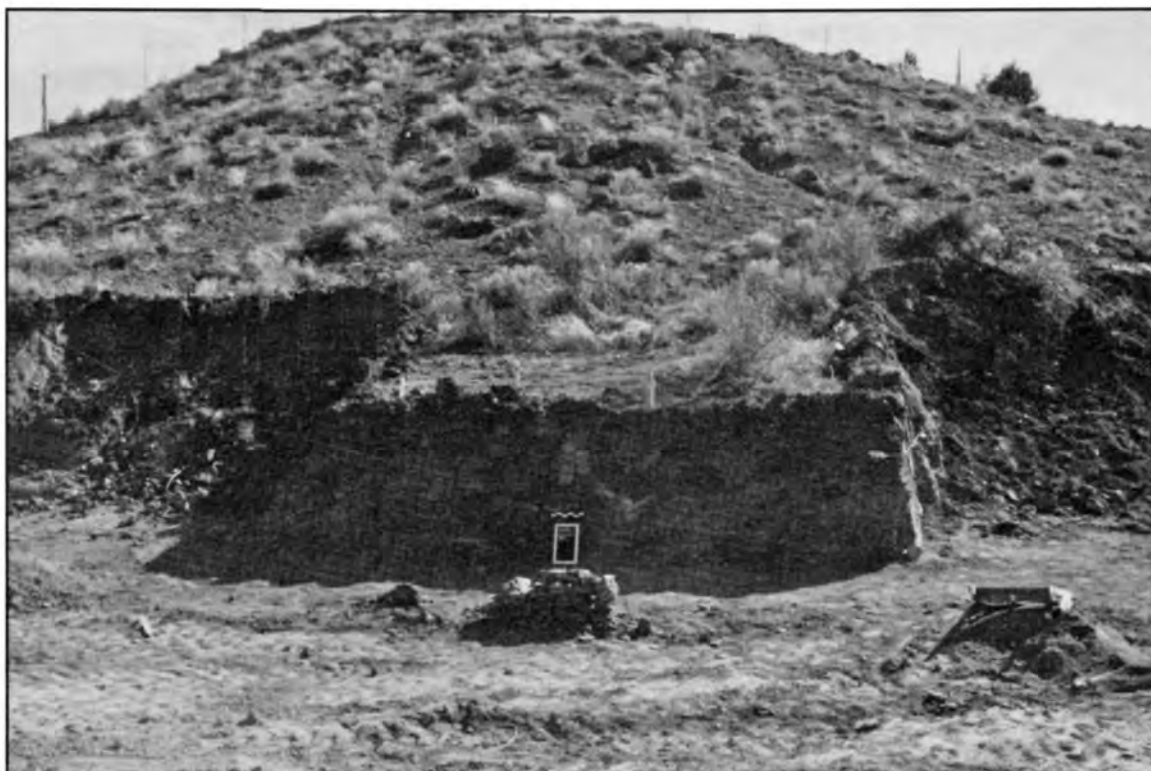
**Figure 2.7.** Overview of baulk remnant left by heavy equipment.

Thunderbird Cafeteria. Construction for the expansion of the cafeteria parking lot had removed all visible signs of the structure, down to a 5-by-1.5-foot segment of the southeast room corner contained in the western half of a 18-by-10-foot balk (Figure 2.7). No evidence of the structure's west or north wall remained, much less any indication of multiple rooms, because blading had removed fill down to the sterile substratum. A thin lens of trash was visible 30 feet north of the room in a small balk left as a core for a traffic pier (Figure 2.8). This indicates that archeological integrity of the entire structure, although considerably degraded on the north, existed along with a scattering of extramural trash prior to parking lot expansion.

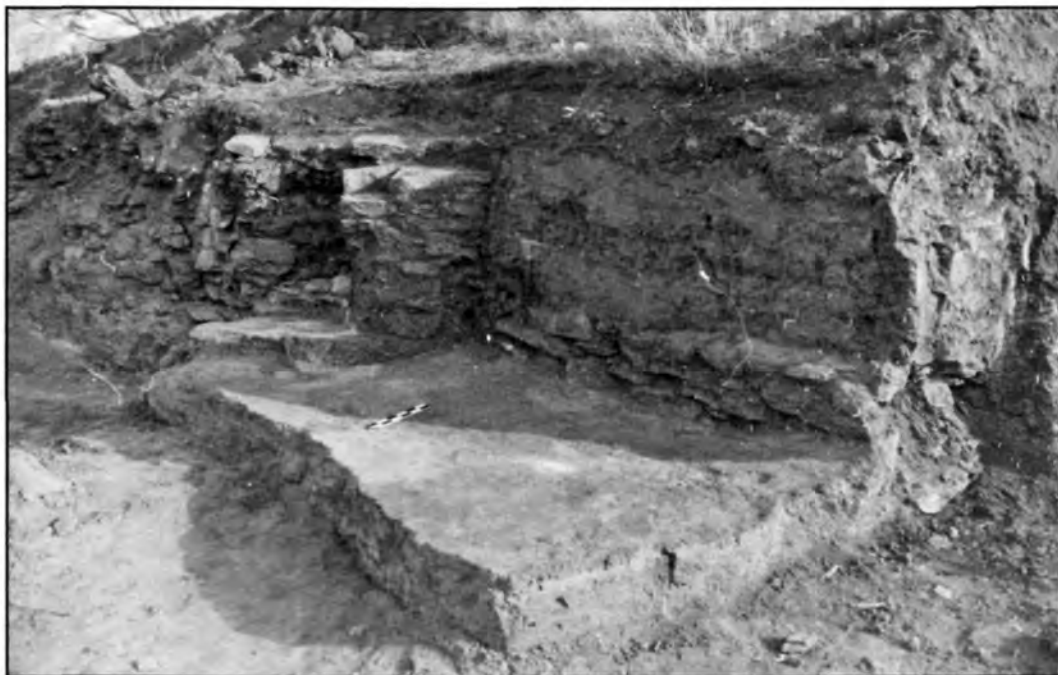
**Figure 2.16** Overview of excavated room remnant (30cm scale to north).

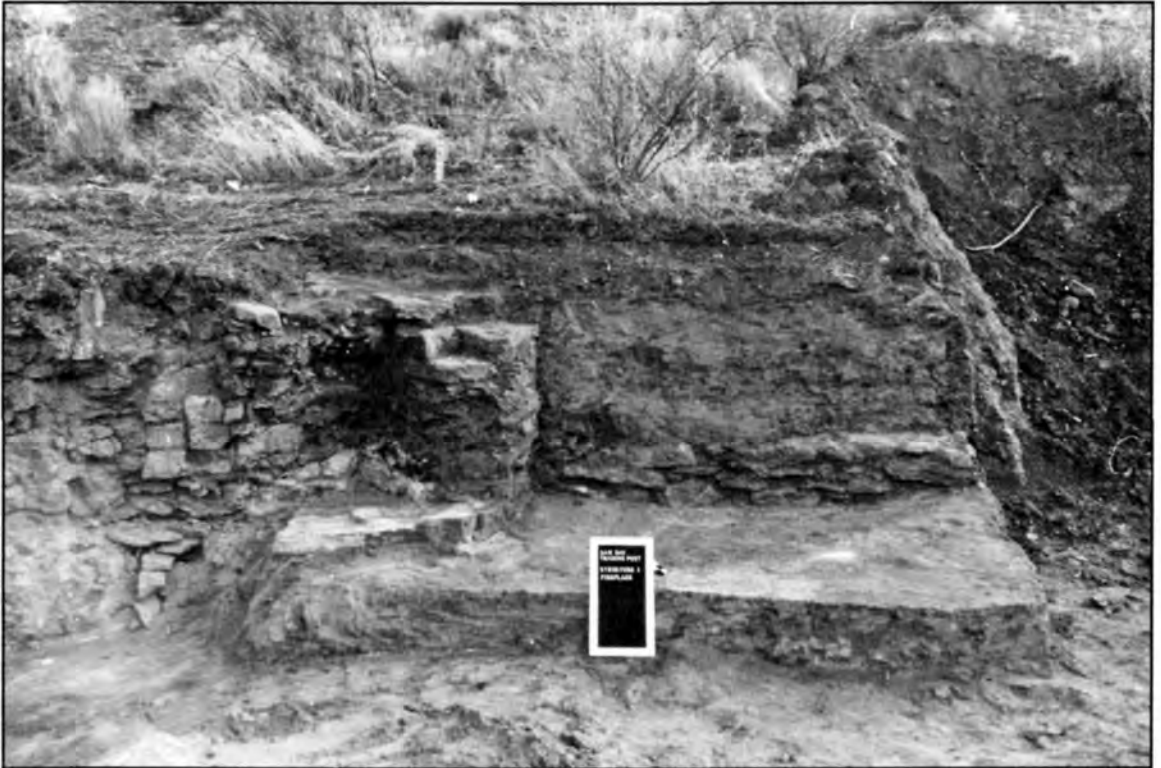
**Figure 2.18** Overview of excavated room remnant: view to south.
