NOVEMBER 26, 1984

# Aviation Week & Space Technology

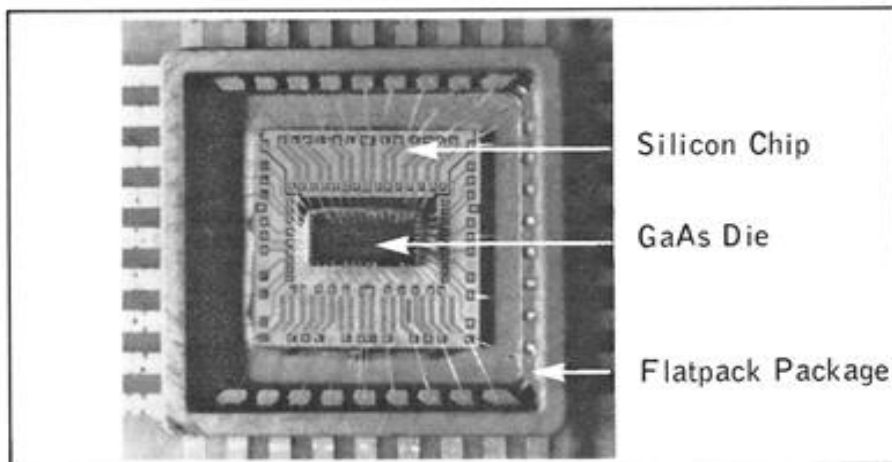
### Company Develops New Microcircuit Packaging System

**New packaging technique** for gallium-arsenide digital microcircuits, designed to allow operation at a clock rate of 4 GHz. (100 picosec. signal rise/fall time), has been developed by GigaBit Logic. By mounting the gallium-arsenide logic chip on a silicon substrate, which contains power supply decoupling capacitors, these can be located much closer, which also reduces inductance from long interconnections. The silicon chip also provides terminating resistors for input signals to minimize reflections and shielded micro-strip transmission lines to reduce cross-talk. GigaBit has applied for a patent on its new packaging technique.

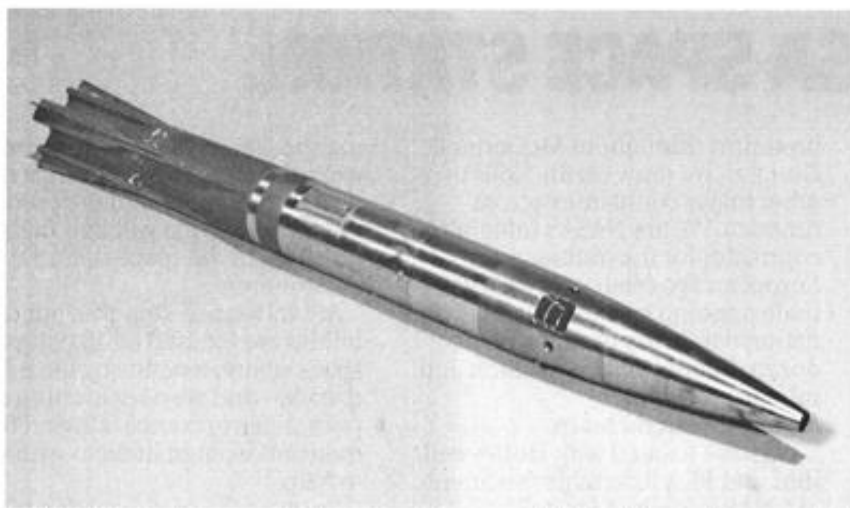
## Ford Test-Fires Projectile With On-Board Computer

Ford Aerospace & Communications Corp. has successfully test-fired a 40-mm. guided projectile that is equipped with an on-board computer designed to maneuver off the projectile's initial ballistic trajectory. The rectangular opening visible here—located near the nose of the projectile—is one of two ports that provide in-flight guidance for the device through the preprogrammed ram air guidance system. The projectile, which was fired from a special test cannon at a site near San Juan Capistrano, Calif., was developed for the Air Force Armament Laboratory by Ford Aerospace's Aeronautics Div. in Newport Beach, Calif. The projectile measures approximately 17 in. long.

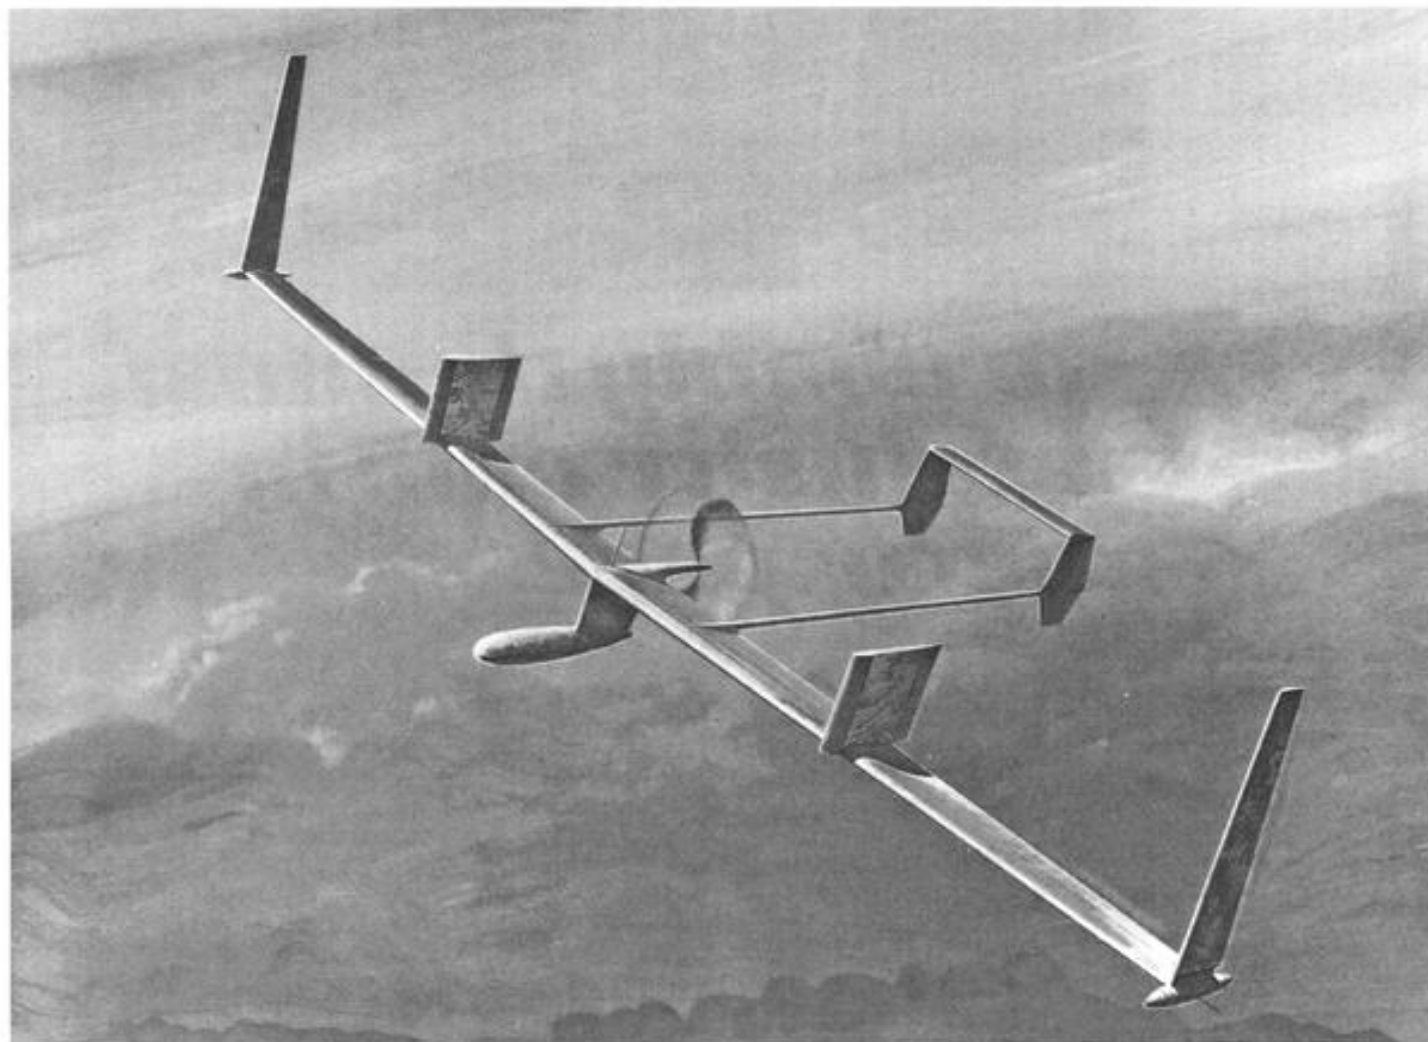
## Lockheed Investigates Solar-Powered Platform

**Solar-powered, high-altitude** unmanned aircraft, intended to operate for at least a year at altitudes of about 65,000 ft. as a platform for sensors or communications relay payload, is under investigation by Lockheed Missiles & Space Co., funded in part by NASA's Langley Research Center. Surplus electric energy collected during daylight from solar cells mounted on wingtips and vertical stabilizers would

separate water into oxygen and hydrogen for use at night by a fuel cell to generate electric energy. Propeller, measuring about 40 ft. in diameter, is expected to operate at more than 90% efficiency. The payload, carried in an underslung pod, could weigh up to 200 lb. At 65,000-ft. altitude, solar-power generated thrust would be sufficient for the aircraft to hold its position.
